Re: Silver Gate Ranches Proposed Subdivision, Pace Ranch Property, Park City, UT

Letter from SAGE Environmental, L.L.C. and Attached Figures and Reports Summarizing Sampling Results for the Pace Ranch Property

SOIL SAMPLING REPORT SILVER GATE RANCHES PROPERTY APRIL 11, 2014

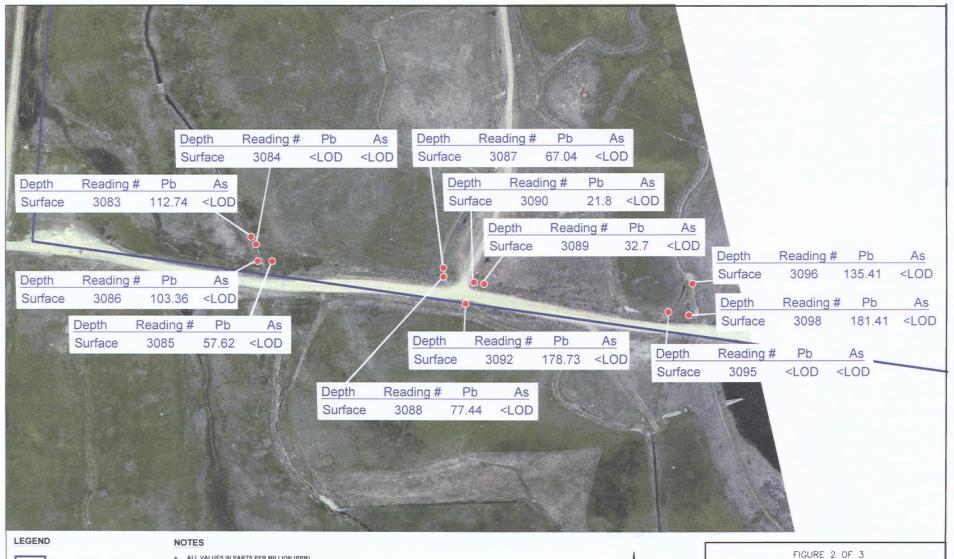
FIGURE 8

- ALL VALUES IN PARTS PER MILLION (PPM)
- SAMPLE LOCATIONS AND BOUNDARIES APPROXIMATE SAMPLES AND XRF READINGS COLLECTED IN JULY 2015
- ILLUSTRATION CREATED IN OCTOBER 2016

Two locations in the northwest portion of the Property and two locations outside the northwest Property boundary were also screened using the XRF (a total of 11 separate readings; Figure 8). The XRF was used to screen soil from on-Property test pit locations OU2-0-SO-50P and OU2-0-SO-51P prior to the collection of samples for laboratory analysis. An off-Property test pit (OU2-SO-OP1) located west of the Pace Ranch fence line on the State of Utah Rail Trail right-of-way adjacent to the historic Wortley Loading Dock was also screened at four depths using the XRF. The fourth location screened was the floor of a drainage ditch immediately upgradient of loading dock test pit OU2-SO-OP1 (XRF reading #3110). Of these 11 XRF readings, only two from the vicinity of the loading dock on Rail Trail property exceeded the LSC Adopted OU1 soil screening level for lead (XRF reading #3102, surface: 2,658 ppm and XRF reading #3103, 1 ft.: 970 ppm).

Soil samples were collected for laboratory analysis from the two locations specified in the SAP (inside the northwest Property boundary, OU2-0-SO-50P and OU2-0-SO-51P). A duplicate sample was also collected from OU2-0-SO-50P. The field team also collected a set of "opportunity samples" from four depths in the off-Property test pit west of the loading dock (OU2-0-SO-OP1) based on the elevated lead concentrations observed during the XRF screening. The results of the laboratory analyses are shown in red text on Figure 8. The samples collected from the two northern-most locations (OU2-SO-50P and -51P) on the Property were well below the LSC Adopted OU1 soil screening levels for lead and arsenic. The opportunity sample from west of the Loading Dock on the Rail Trail property, OU2-SO-OP1, contained high concentrations of lead and arsenic in the upper foot of soil (maximum concentrations of 9,960 mg/kg lead and 268 mg/kg arsenic), but the underlying soil was uncontaminated.

Figure 8. UPCM 2015 Sampling Results, Northwestern Pace Ranch

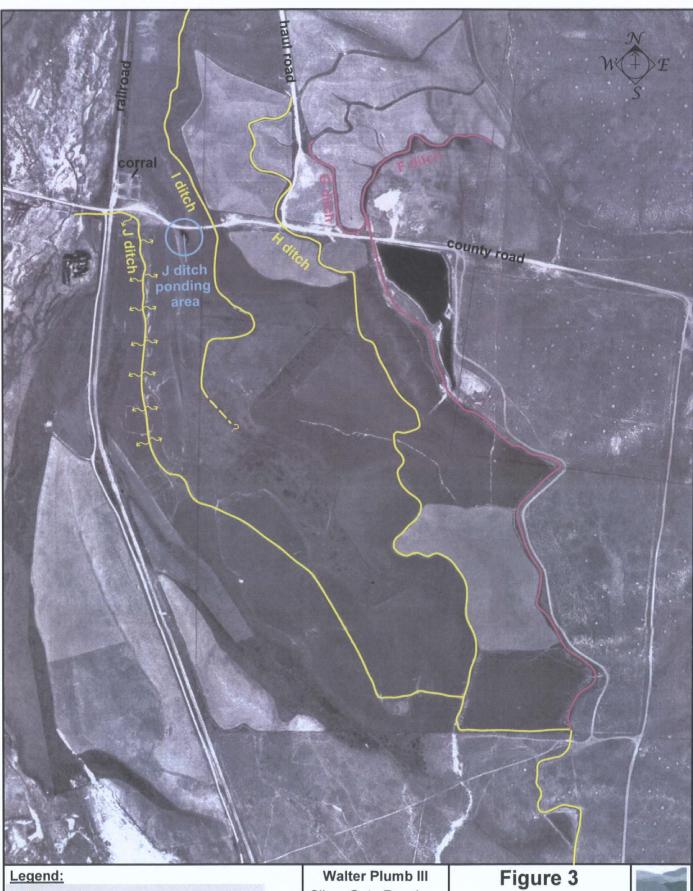
1967 Aerial Photo showing irrigation ditches

irrigation ditch

historic ditch (no longer in use)
